CONTRACT PROFILE

Kitchen refurbishment for the Camden (Education Dept.)

Gospel Oak School

Contract Value: £486,000

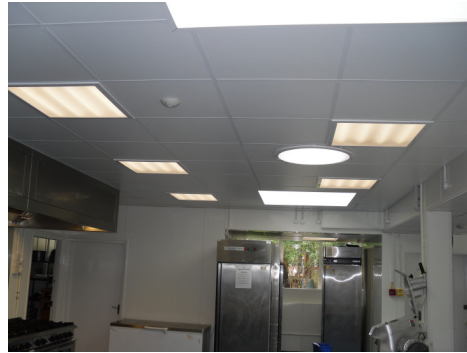
New copper hot & cold water pipework serving all sinks installed complete with isolation valves.

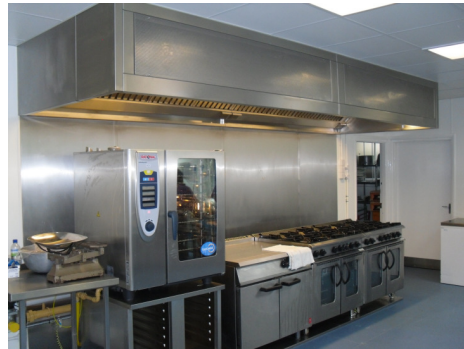
The new ventilation plant has been set to work in accordance with design conditions and manufacturers recommendations.

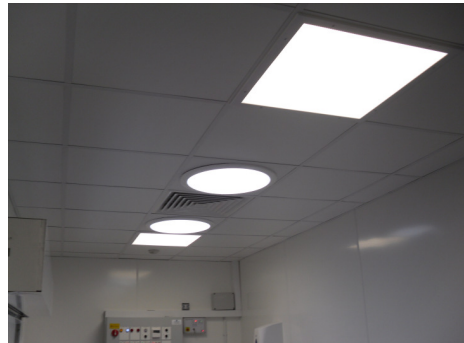
Modification of existing roof (trusses, beams, joists, etc) to allow the ductwork and 'Suntubes' to be installed. Additional roof trusses, beams, joists, etc; installed as necessary to maintain the structural integrity of the roof.

Roofing works carried out by a specialist roofing Contractor. All exposed areas made good on completion of works to closely match the existing roof.

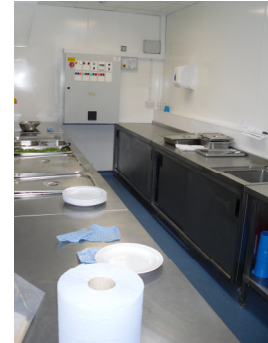
White rock' wall cladding installed to provide a hygienic cleanable surface.

The wall cladding installed from floor level to new false ceiling level complete with all proprietary trims, ends, corners, top and bottom sections, etc.
